Inspection Report

Minerals Regulatory Program

Mine Name: Tony M
Operator Name: U. S. Energy

Permit number: M0170001
Date: August 29, 2006
Time: 7:30 to 11:00 AM

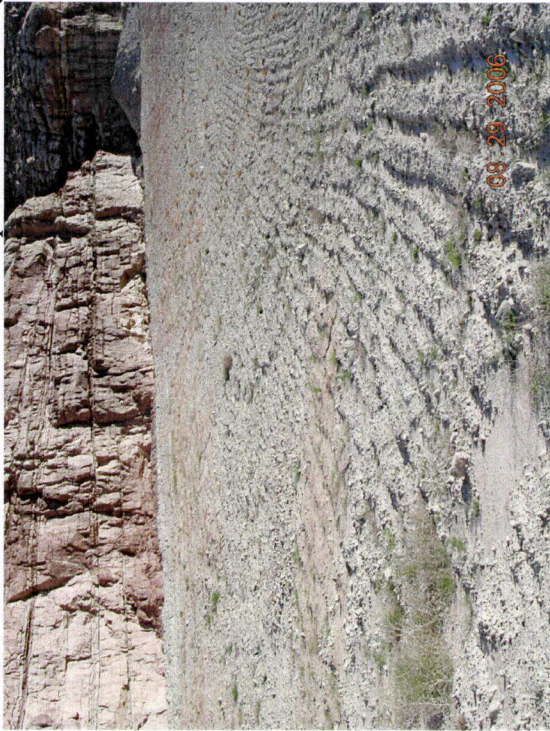
Little soil was available for reclamation of the waste rock pile, but we noticed a distinct difference between areas where soil was and was not used (see Photo 1). In several places near the top of the waste pile, a very thin (<1 inch) layer of soil was placed over the waste rock, yet these areas had about as much vegetation cover as undisturbed areas.

Photo 1. The main waste pile. Note the brown areas where the limited soil was placed over the waste.

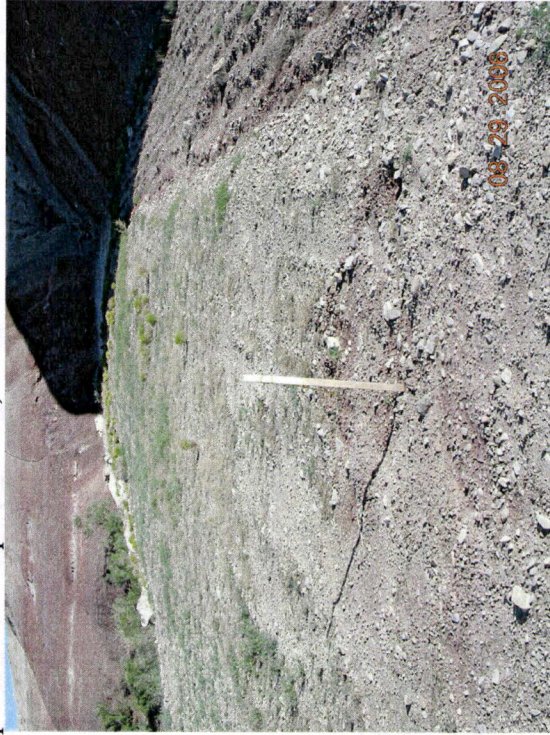
We found markers where it appeared IUC had been drilling (Photo 3). The holes had been filled. Most of the road leading to the dam was open except the last portion which is covered with riprap.

Photo 3. Drill location on the pond embankment.

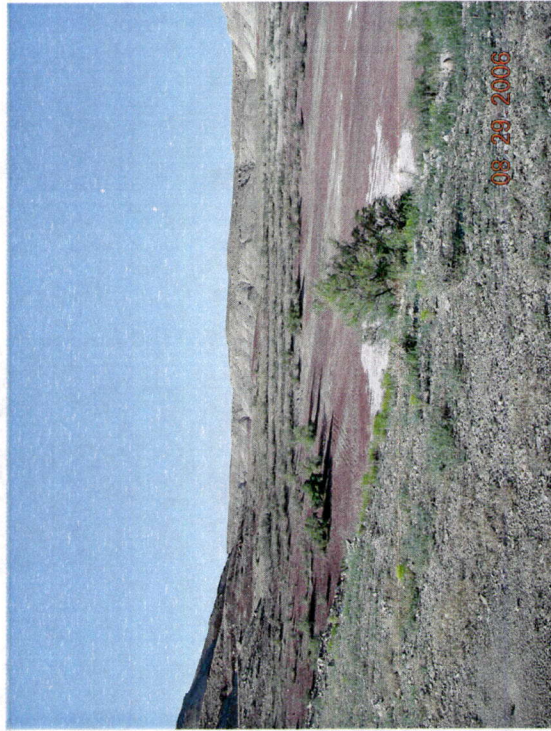
Photo 2. The mine water discharge pond.

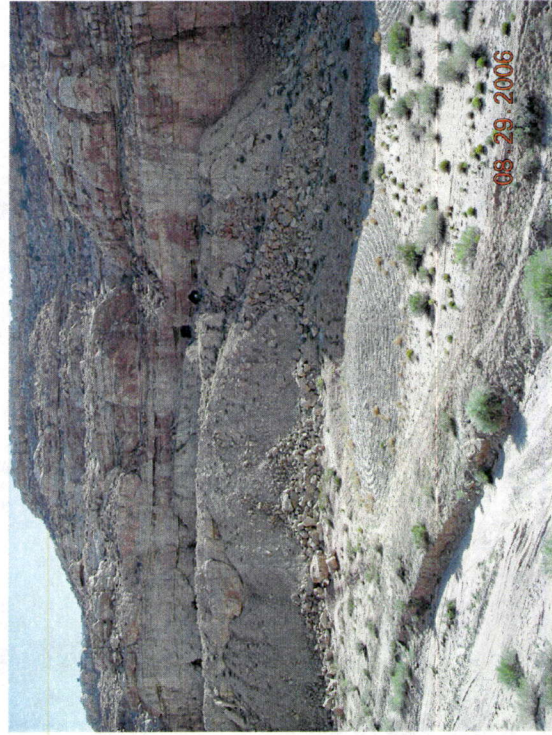
Photo 4. One of the ore piles is shown in the lower center portion of this photo.

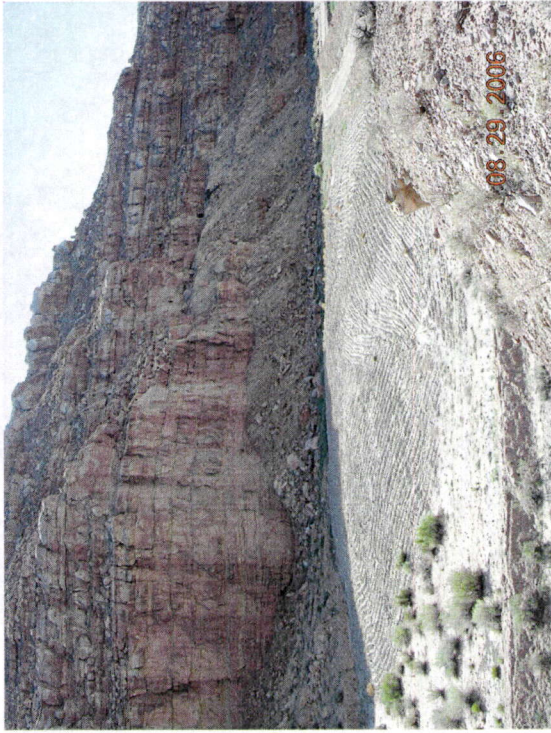
Photo 5. Another ore pile.

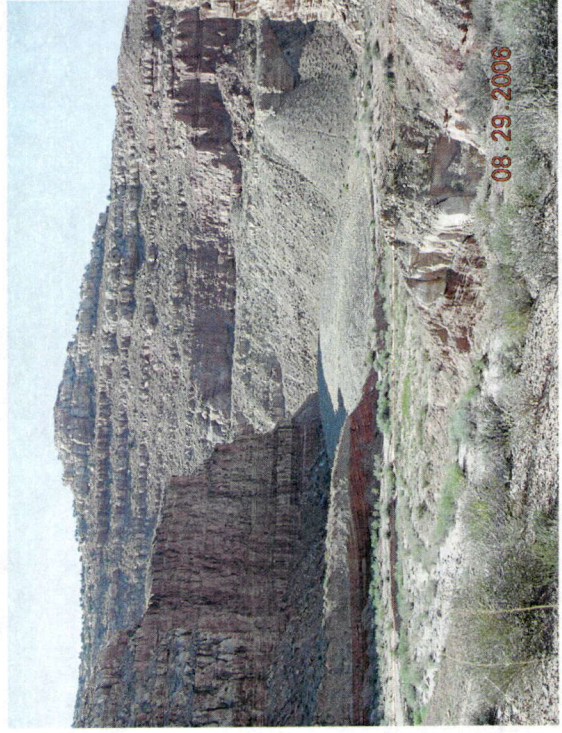
Photo 6. Another ore pile.

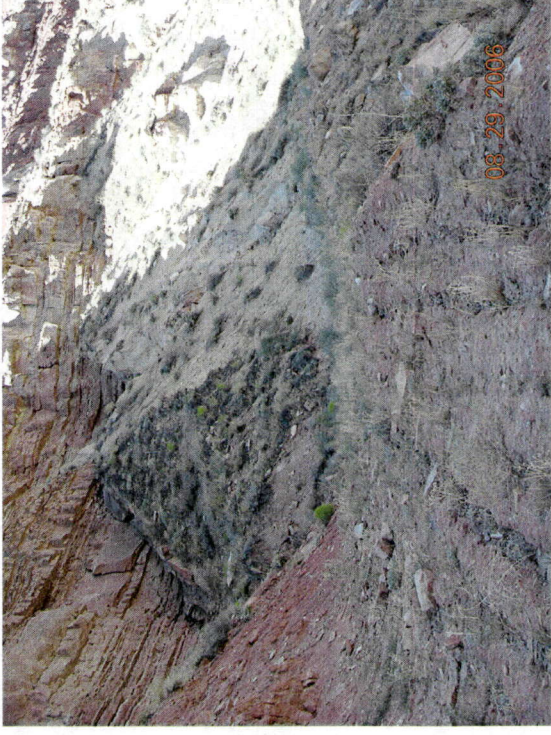
I did not take cover measurements on the road leading to the Lucky Strike portals, but the cover in this area looked very good (Photo 7).

Photo 7. Road leading to the Luck Strike Mine.
